Performance evaluation of a rectifier column using gamma column scanning

Denis D. Aquino, Janice P. Mallillin, Ramoncito F. Sulit, Frederick C. Hila, Ivy Angelica A. Nuñez, Adelina D. M. Bulos

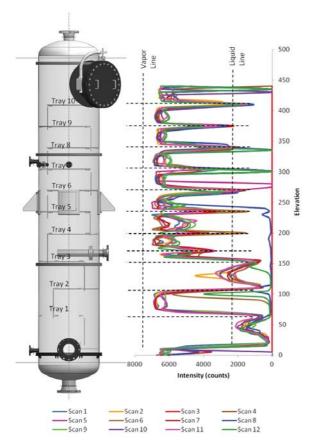
Fig. 3. Resulting density profiles for each scan.

Scan 1 reflects the presence of all trays at their respective positions. Interestingly, the intensities dropped at the vapour level between trays 2 and 3, and between trays 4 and 5. Radiation intensities at these levels are expected to be high since there are no obstructions along the pathway of the gamma rays. These same observations were also present in scans 2, 4–7 and 9–11. The low radiation intensities that were detected may be due to a high liquid level due to weeping, foaming or a blockage. Low radiation intensity readings were also recorded just below tray 1 in these scan lines which could indicate a high liquid level at the bottom of the column or a high density material below the tray obstructing the gamma rays along the pathway.

Flooding conditions were observed during scans 3, 6, 8 and 12. During scan 3, flooding started in tray 1 and reached up to tray 7. Flooding during scan 6 reached tray 1, while during scan 8, it reached tray 5. During scan 12, flooding rose up to tray 2. The differences in the height of the tray up to which flooding occurred could be attributed to the varying feed-rate settings during the scans.

The gamma column scanning technique was used to determine the operating conditions of a rectifier under various process parameter settings. Twelve scan lines were plotted to represent the conditions inside the column under twelve parameter settings set by the operators. Scan lines 1–2, 4–7 and 9–11 indicate unexpected low radiation intensities at the vapour level between trays 2 and 3, and between trays 4 and 5. This could indicate a high liquid level due to foaming, weeping or a blockage.

The technique was also able to identify the occurrence of flooding under certain parameter settings as reflected in scan lines 3, 6, 8 and 12. This could possibly be attributed to the parameter settings such as the different feed rates as well as the presence of a blockage along the pathway of the liquid flow.
