Two significant experiences related to radon in a high risk area in Spain

Abstract. Radon is a natural radioactive gas and it is currently accepted as being responsible for lung cancer in some cases. One of the most important sources of indoor radon is from the soil. The radium content of soil is also a very important factor to be taken into account. The natural radiation map of Spain (MARNAs) classifies the country into three regions with different levels of natural gamma radiation. There are some areas in Spain with high levels of natural radiation one of those is the province of Salamanca. Western part of this province presents a population of 20 000 inhabitants and 7% of the houses have an indoor radon concentration above $400 \text{ Bq}\cdot\text{m}^{-3}$. In this high risk area, the village of Villar de la Yegua is of special interest: 11% of the houses in this village have an indoor radon level below $400 \text{ Bq}\cdot\text{m}^{-3}$, 89% have above $400 \text{ Bq}\cdot\text{m}^{-3}$ and 71% of the houses have a radon concentration above $1000 \text{ Bq}\cdot\text{m}^{-3}$. An old uranium mine site close to this village has been selected for the construction of an experime

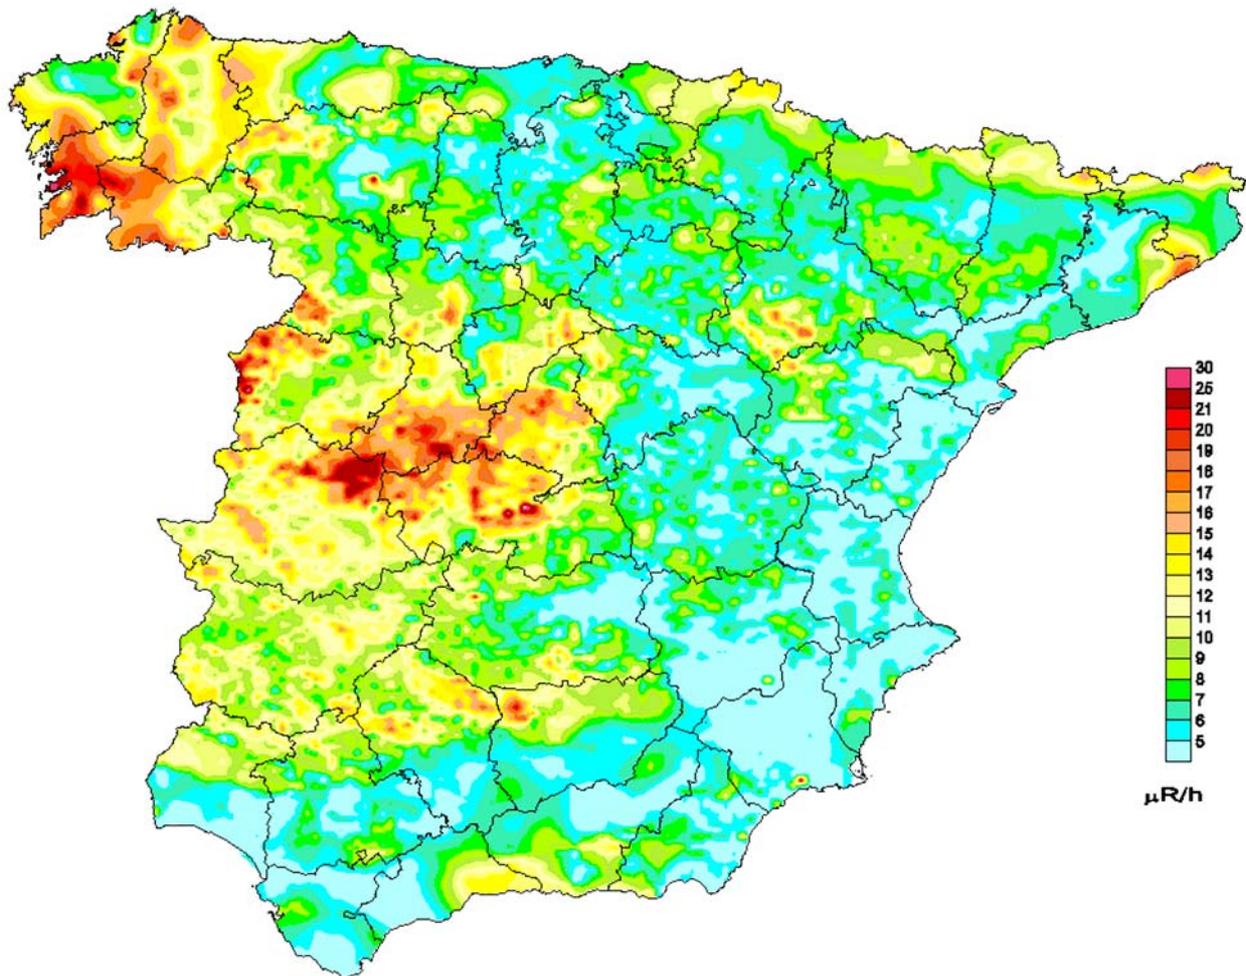
Fig. 1. Map of MARNA project in the Iberian Peninsula.

It is widely known that radon gas is the main source of annual radiation dose. In the case of Spain, annual dose due to radon represents 47% of the total dose received by general population [5]. In 1991, a project to determine the estimation of the radon concentrations started. This was called the MARNAs project and it concluded in 2004 [6]. The Radon Group at the University of Cantabria started to work on radon surveys in 1988. The Spanish Radon Programme started its activities at that time. The Radon Group carried out a series of radon surveys to get around 2000 values of radon concentration indoors. These results are a very useful tool in order to determine high background radiation areas (HBRA) in Spain [7]. The results of the MARNAs project classifies Spain into different areas according to the different levels of gamma radiation. A map of MARNAs project can be seen in Fig. 1.

From the results of MARNAs project, we can identify very high levels of natural radiation in areas of the Iberian Peninsula. The highest levels are located in

the northwest of the peninsula corresponding to Galicia. Other high levels are located in the centre of the peninsula and in two provinces on the border with Portugal. These areas are composed essentially of granitic rocks and there are also some uranium mine sites in the provinces with high levels in the Portuguese border. The highest indoor radon concentration ever found in Spain corresponds to a village located in one of these provinces named Villar de la Yegua. A value of $15\,000\text{ Bq}\cdot\text{m}^{-3}$ was found here [9]. If we take into account all the sources of natural radiation, a mean effective dose of 267 mSv per year was estimated in this village. According to the European recommended action level for old houses of $400\text{ Bq}\cdot\text{m}^{-3}$ [1], 89% of the houses of this village present radon indoors concentrations above this action level.

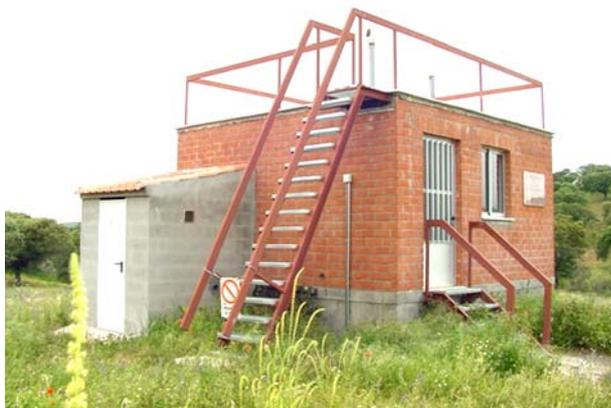
Fig. 2. Global view of experimental pilot house.

The design of the experimental module developed corresponds to the basic characteristics of detached house located in rural environment, without using modern constructive systems. It is a 2-floor house with 25 m² of surface in each floor. There is a semicellar buried 2 m free height and a ground floor 2.4 m of free height. A global view of the house can be seen in Fig. 2. The walls of the cellar have 1 feet of thickness and are made of crude bricks. The ground floor presents walls 0.5 feet of thickness and made of bricks. There is a polyvinyl chloride (PVC) pipe in the centre of the ground floor 120 mm of diameter. The joints of the PVC pipe are made of elastomeric fillers. Two windows, one at the front and another at the back are situated in the ground floor where it is also placed the main gate of the construction. The stairs 1 m wide are used to communicate

the ground floor and the semicellar. The steps of the stairs are 0.25 m wide. The house is lying on a base made of concrete 15 cm in thickness. The walls are composed not only of bricks but also of gypsum and polystyrene.

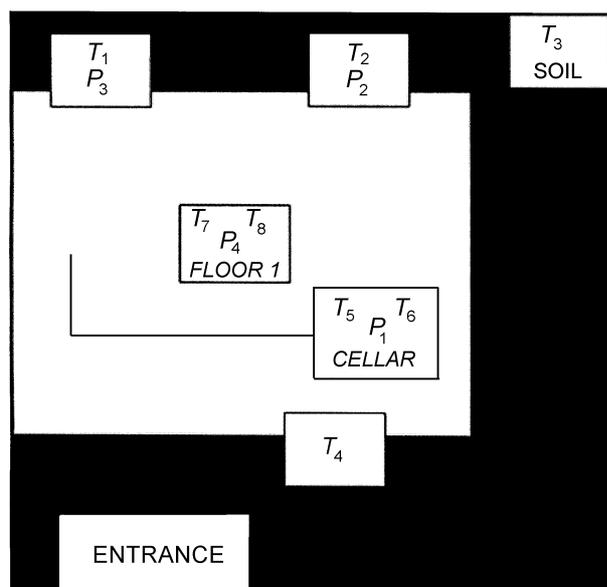
Fig. 3. Placement of meteorological sensors inside the experimental pilot house.

Not only radon inside the house was measured, but also meteorological parameters were determined. With this aim, 8 different temperature sensors ($T1...T8$) and 4 pressure difference sensors ($P1...P4$) were placed in the house. It can be seen in Fig. 3 a schematic view of the placement of these sensors. Another meteorological parameters were also provided by a nearby station: mean wind velocity (m·s⁻¹), maximum wind velocity (m·s⁻¹), mean wind direction (°), mean air temperature (°C), maximum air temperature (°C), mean relative humidity (%), mean pressure (mbar), mean solar radiation (W·m⁻²), maximum solar radiation (W·m⁻²),

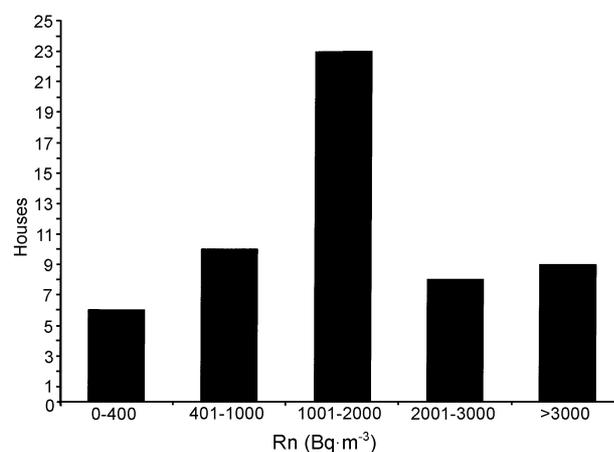
Fig. 4. Distribution of the radon indoors concentrations in the houses of Villar de la Yegua (Spain).

In Fig. 4 we can see the distribution of all the radon indoors measurements carried out in the houses of the village Villar de la Yegua. In the case of the workplaces studied, we found the next values summarized in Table 1: medical consulting room ($55\,830\text{ Bq}\cdot\text{m}^{-3}$), social centre ($4921\text{ Bq}\cdot\text{m}^{-3}$), church ($4253\text{ Bq}\cdot\text{m}^{-3}$), townhall

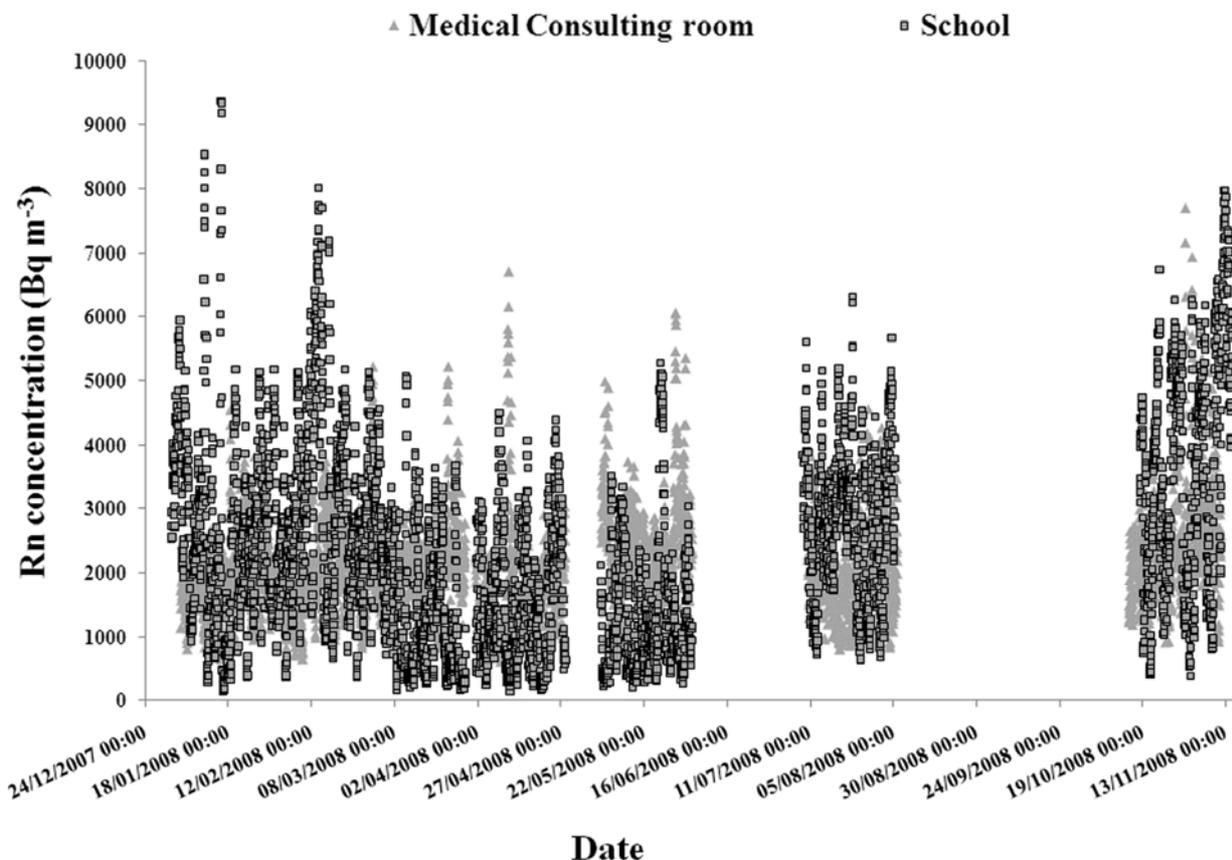
Fig. 5. Radon variation during 1 year in the building shared by the school and medical consulting room in the village Villar de la Yegua (Spain).

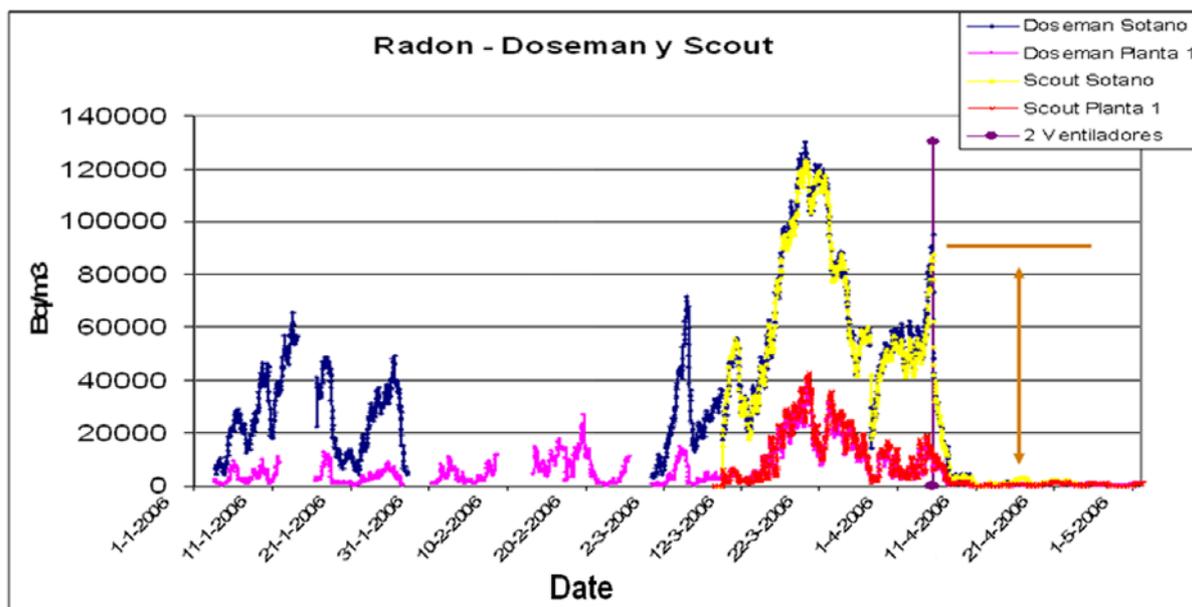
Fig. 6. Effectiveness of the remedial actions tested. The last part of the graph shows the results obtained using the radon barrier.

Taking into account this situation, some remedial actions were proposed to be tested in the house. In Table 2 we can see the effectiveness of the remedial actions tested where central forced extraction was done using an electrical fan in the house. In Fig. 6 it can also be seen the effectiveness of the remedial actions we applied: natural ventilation, forced extraction, pressurization, crossed ventilation and radon barrier. The different curves correspond with measurements using radon monitors in the pilot house. Four of these measurements were done in the cellar and ground floor (marked as “sotano” and “Planta 1” in the legend of the graph, respectively) and the fifth measurement was done under forced extraction using the electrical fan (marked as “Ventiladores” in the legend of the graph). The last part in Fig. 6 corresponds to the use of the radon barrier and the high peak which can be observed is due to those measurements carried out in the cellar of the house. The radon barrier has the possibility of being taken out at any time and after the application

of this remedial action, the mean radon concentration reached was 1700 Bq·m⁻³ for the case of the cellar, and 500 Bq·m⁻³ in the case of the ground floor.
